Three dimensional method for monitoring damage to dolos breakwaters

Thesis presented in fulfilment of the requirements for the degree of
Master of Science in the Faculty of Civil Engineering

Stellenbosch University

Kishan Ramesh Tulsi

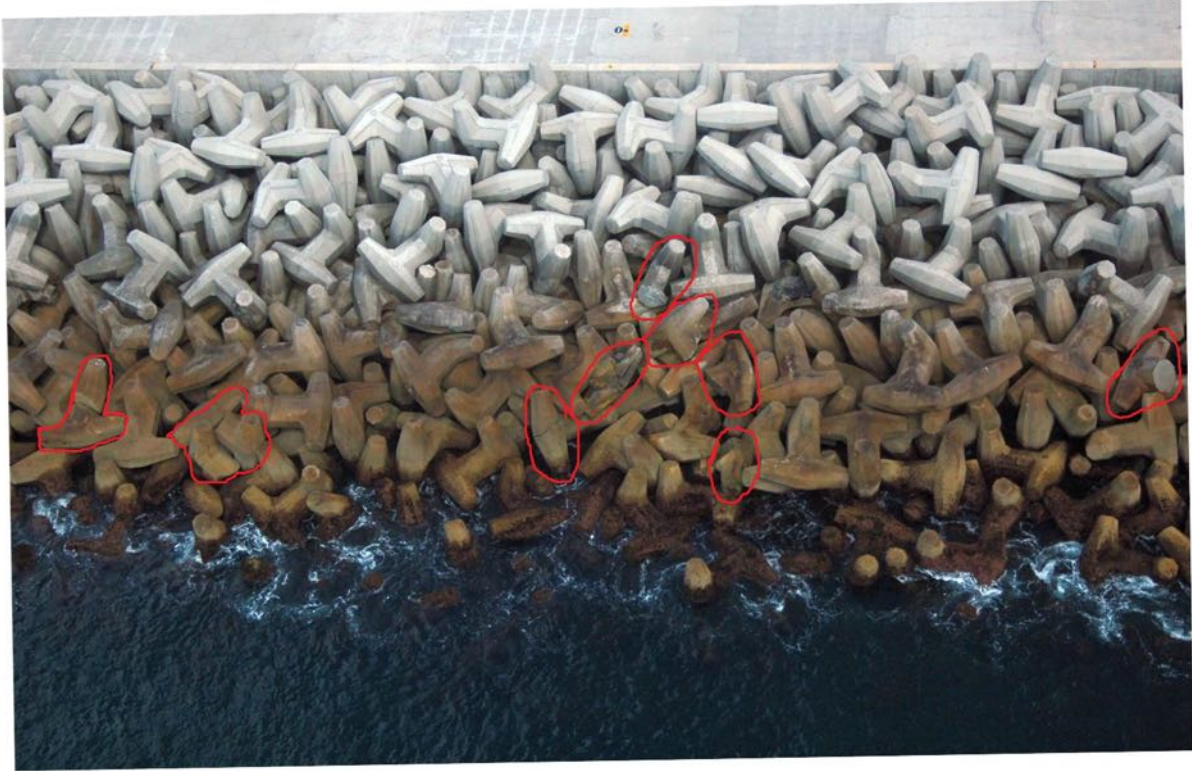
Figure 2.7: Broken dolos units at the Port of Ngqura contributing to slope cover, Photo: K. Tulsi

if settlement or breakage has occurred. An example of dolos units which have broken during settlement or rocking but are contributing to slope stability is shown in Figure 2.7. This figure shows the eastern breakwater at the Port of Ngqura at spring low tide from the 2015 aerial photographic investigation. Some dolos units within the tidal zone have broken, but still are providing cover by interlocking with other units. The correlation of these breakages is estimated at 67 percent related to small movements ($d_{0.5H}$) and 33 percent related to larger movement (d_H) in prototype. This is a complex problem for smaller movements relating to damage Holtzhausen et al. (2000).

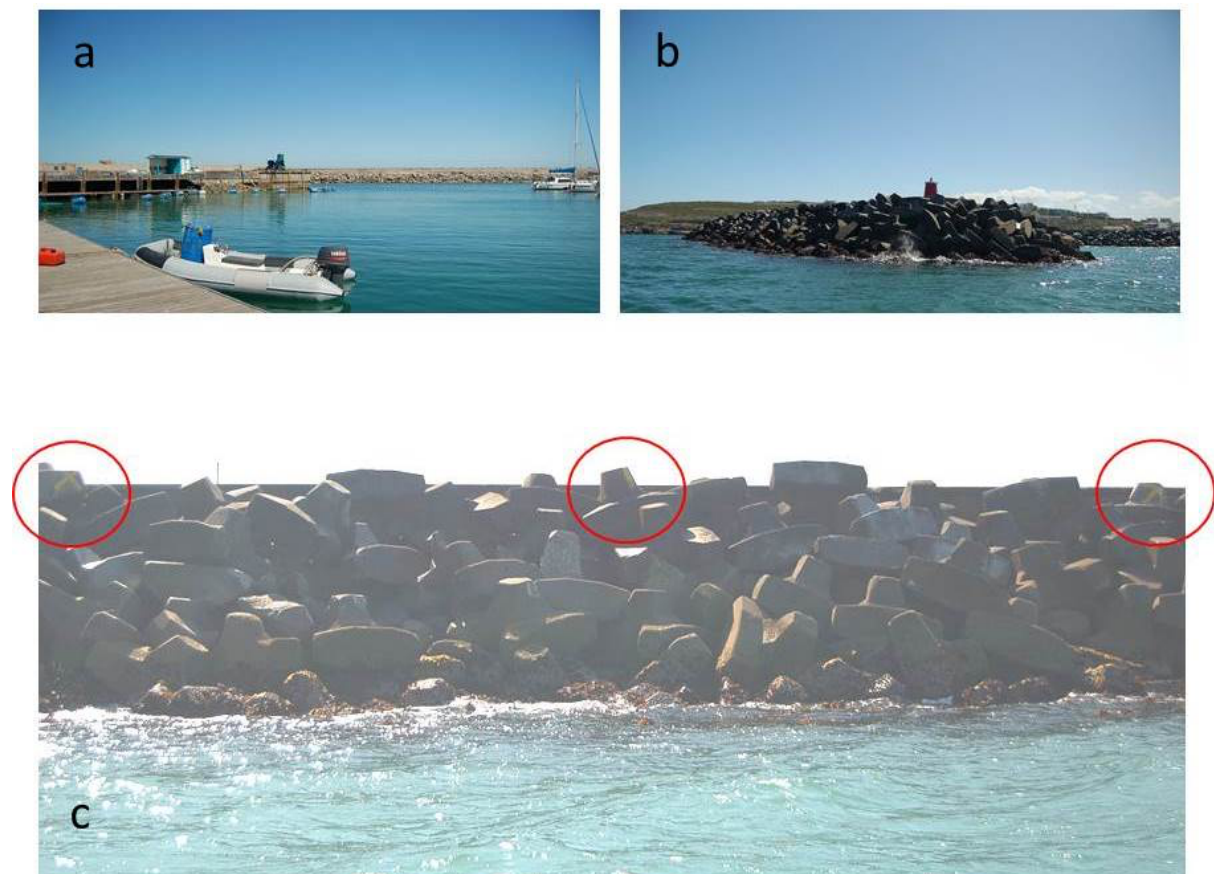
Figure 2.9: Photographic survey from a boat (a) equipment, (b) breakwater, (c) station view, Photo: R. Vonk

A typical survey boat and images of a survey are presented in Figure 2.9.

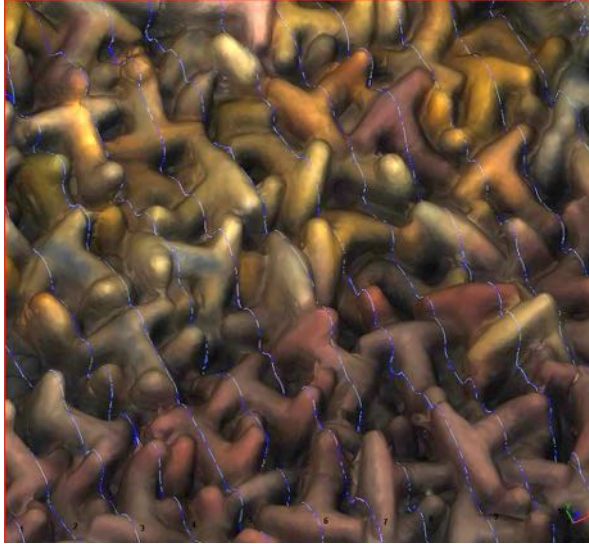
Figure 3.6: Image of mesh and profile at $1D_n$ spacing of scan 1 and scan 3

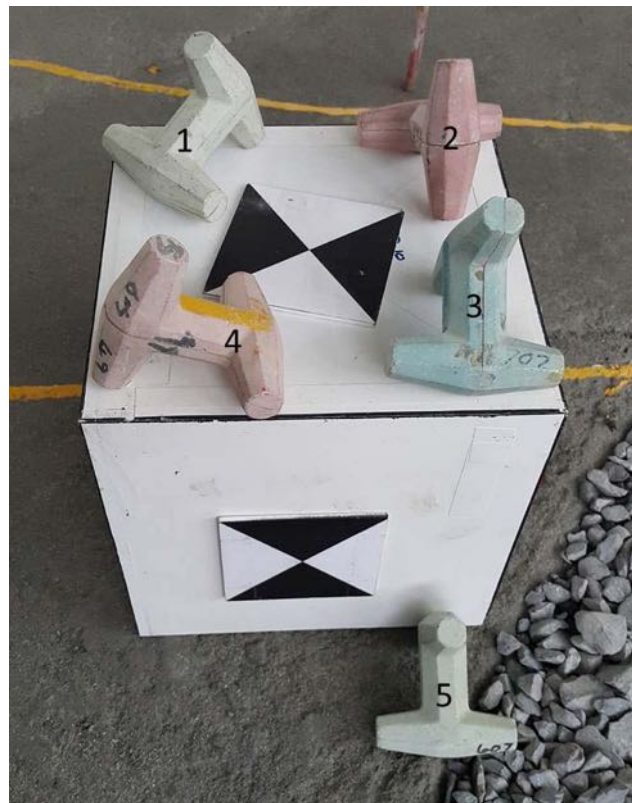
Figure 3.21: Model dolos units used for the mean absolute error measurements

The measurements accuracy check was carried out by scanning five (5) dolos units and a set of callipers. The five units were scanned using the LIDAR scanner and measured using the 3D Reshaper CAD programme. Figure 3.21 shows an image of the five dolos units that were scanned and the calibration box used for the accuracy measurements. The results from the actual measurements are presented in Table 3.9. The accuracy check was done by measuring the height and waist of the dolos units. The average dolos height measurement was 73.9 mm while the waist measurement was 24.46 mm using the caliper. The mean absolute error between the five units was ± 0.22 mm for the Height and ± 0.12 mm for their waist. The units were then scanned and measurements done using the CAD software package. The measurements are presented in Table 3.10.

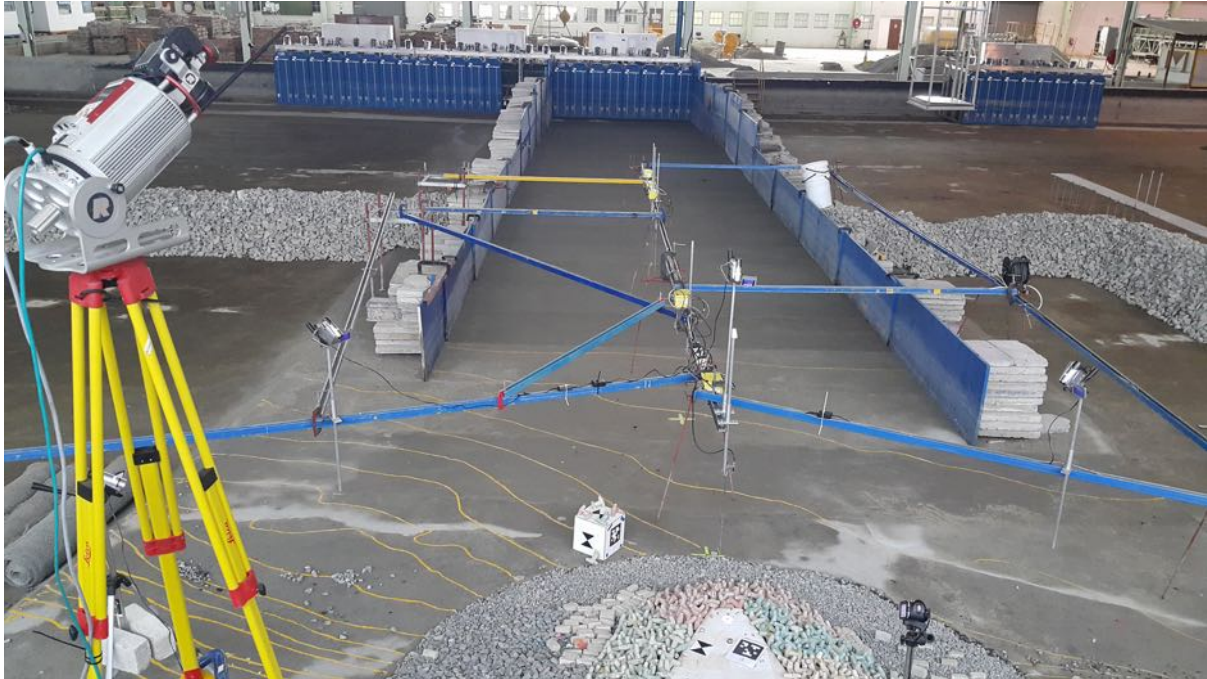
Figure 4.2: The model with scanner (left) and calibration box (foreground)

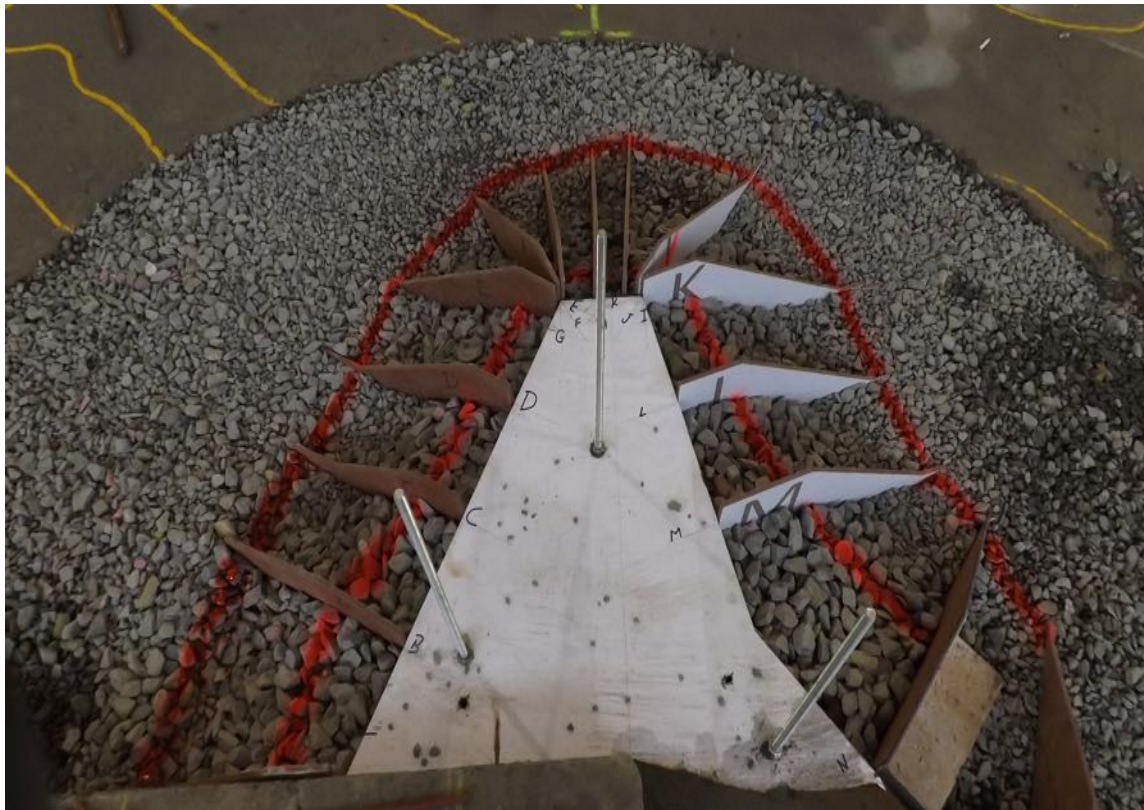
Figure 4.6: Construction of the Cape Town spur breakwater scale model

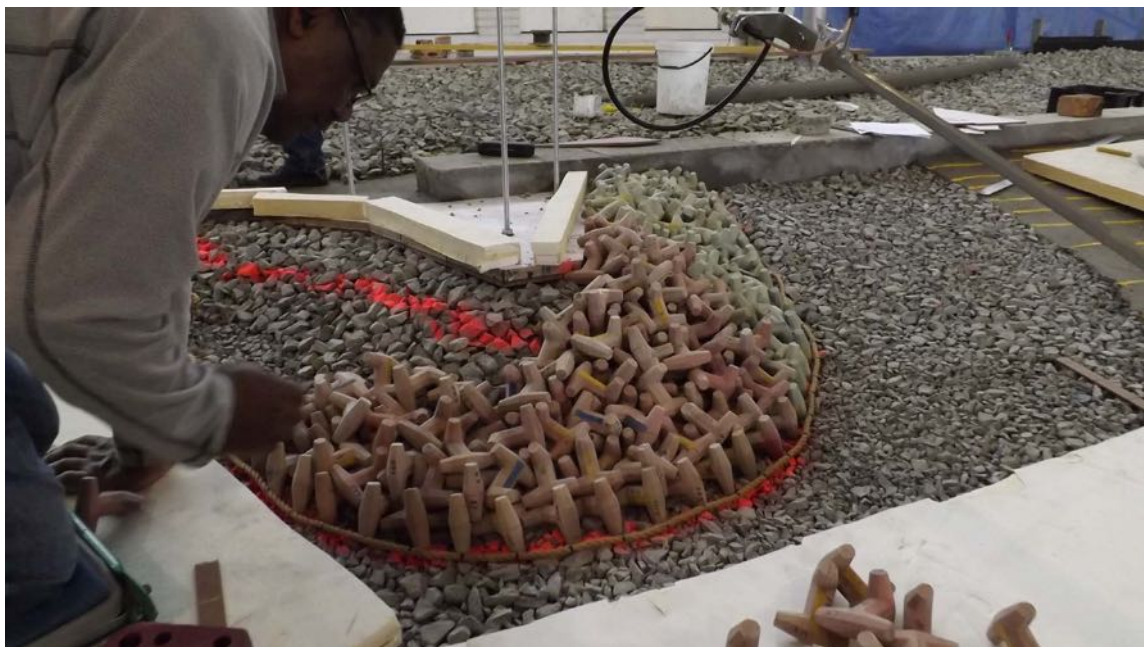
Figure 4.7: Placement of model dolos using the grid spacing

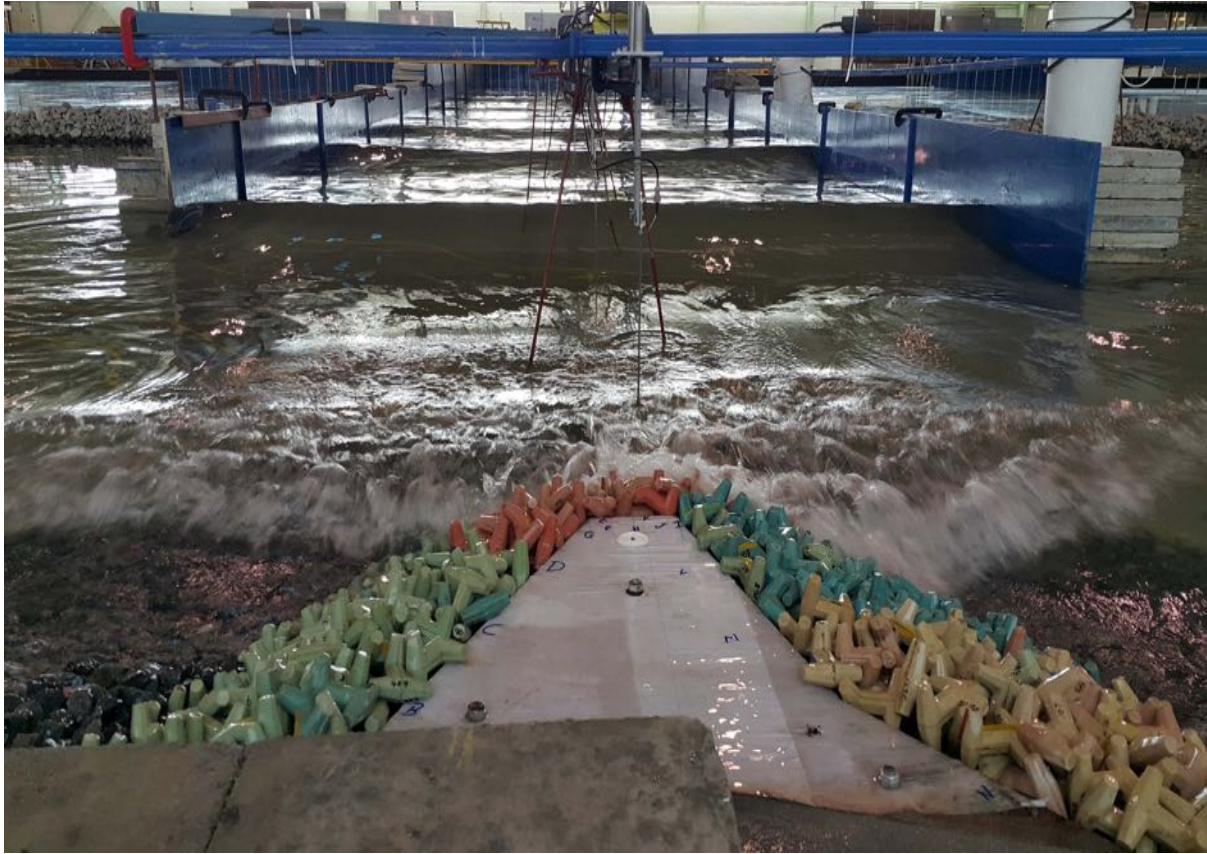
Figure 4.8: View of breakwater stability test for damage accuracy assessment using the two methods

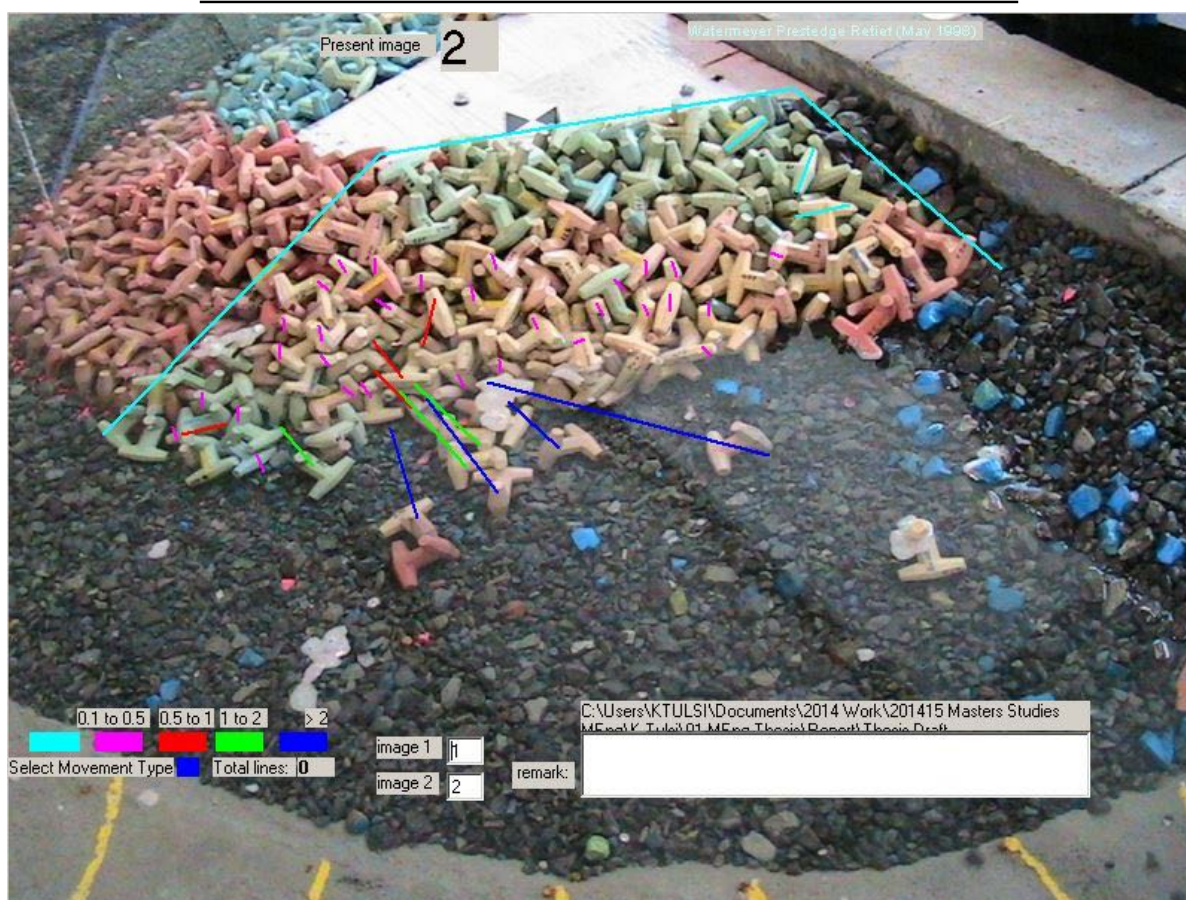
Figure 4.9: Recorded displacement for Test 3.1

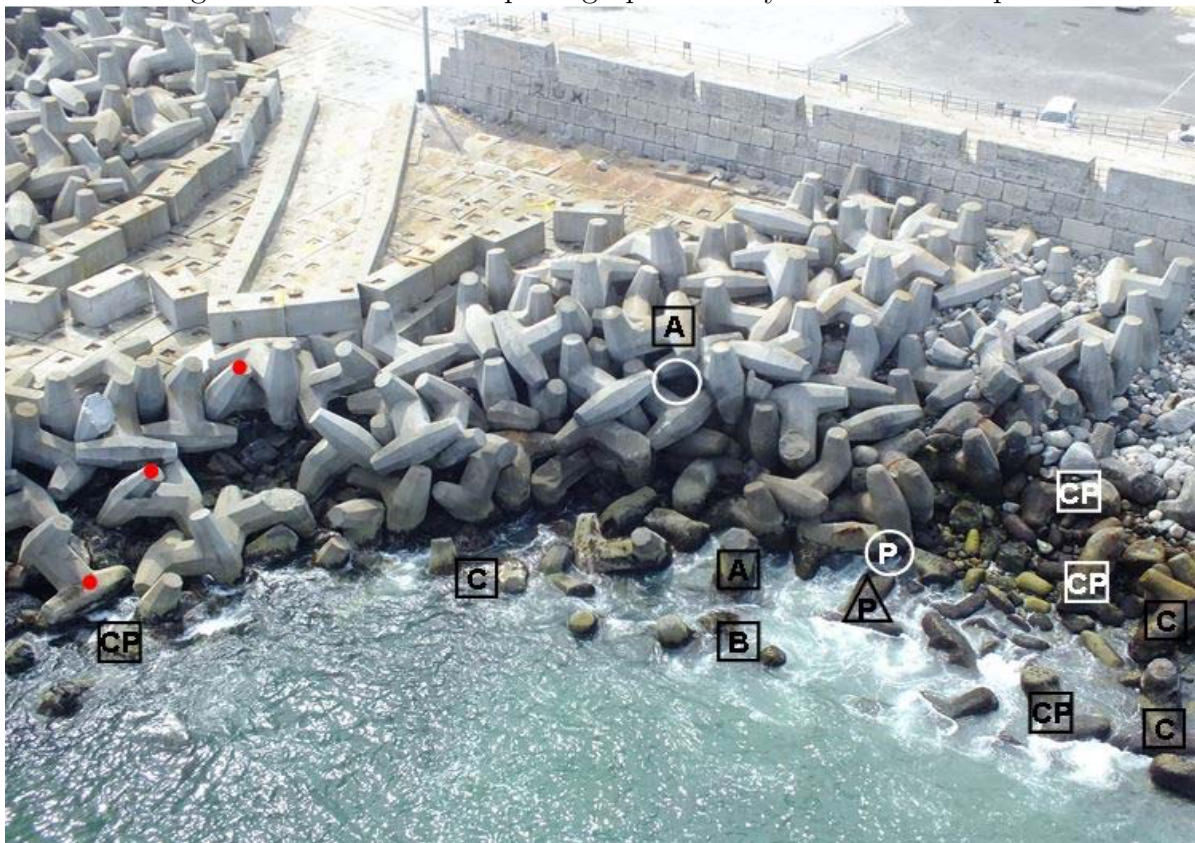
Figure 5.11: 2012 Aerial photographic survey station south spur

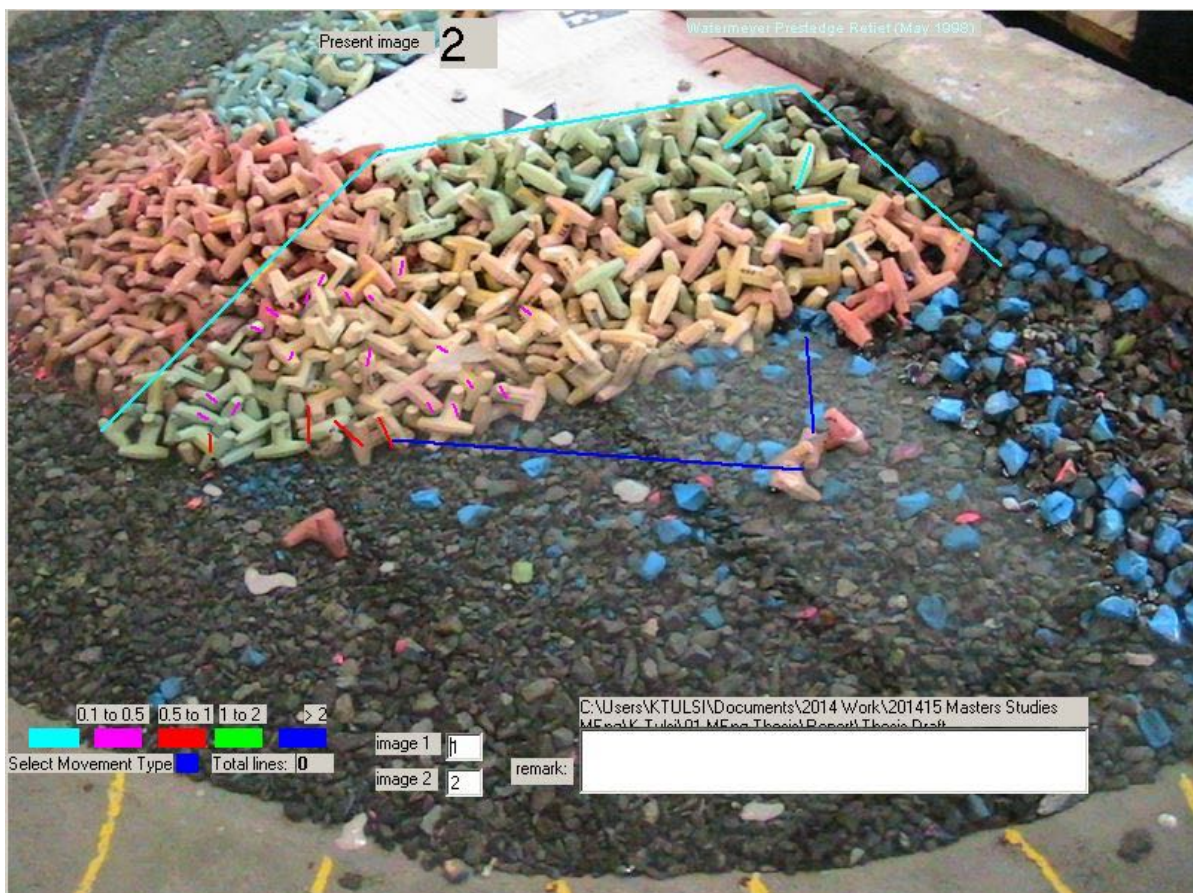
Figure C.6: Recorded displacement for Test 2.1

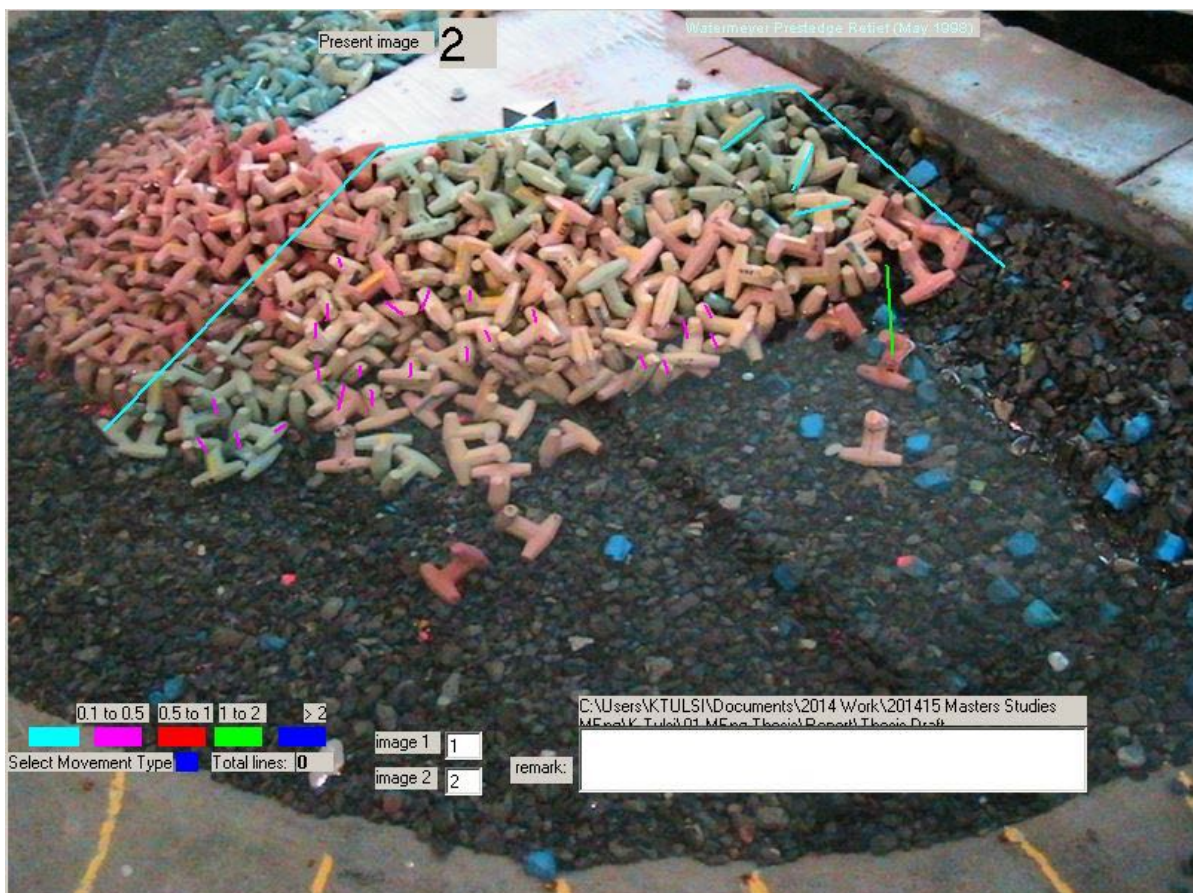
Figure C.12: Recorded displacement for Test 4.1
